# EAST LONGMEADOW DEPARTMENT OF PUBLIC WORKS

Job: Watchaug Forced MAIN REPAIR  
Sheet No: \_\_\_\_\_ of \_\_\_\_\_  
Calculated By: \_\_\_\_\_ Date 9-14-2021  
Scale: \_\_\_\_\_

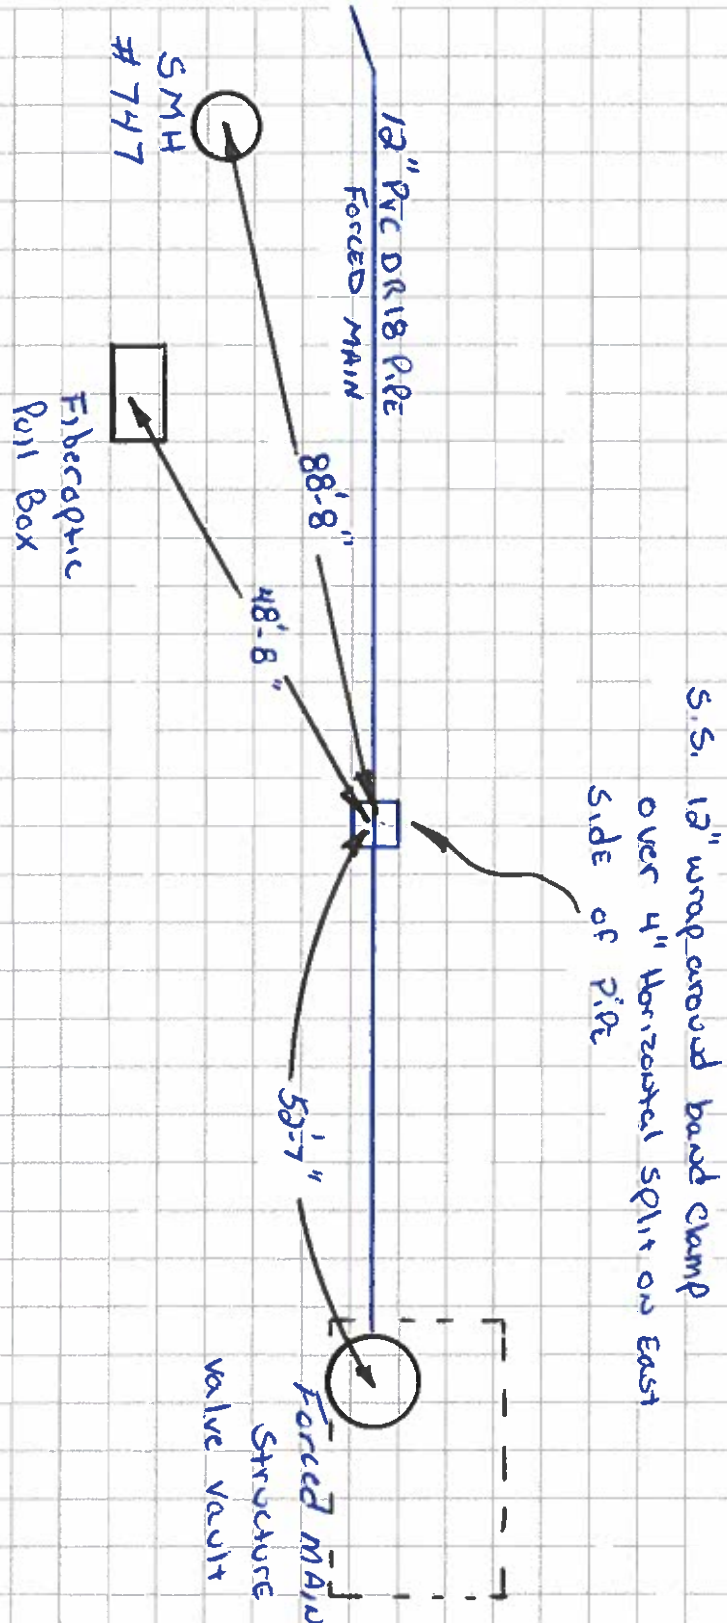
Groove on side of P.P.e appears to have been made by Excavator bucket tooth During original installation.
