# EAST LONGMEADOW DEPARTMENT OF PUBLIC WORKS

Job: # 7 St Joseph Dr Water Service Repair  
Sheet No: 1 of 1  
Calculated By: Foia Date 09/03/20  
Scale: Feet

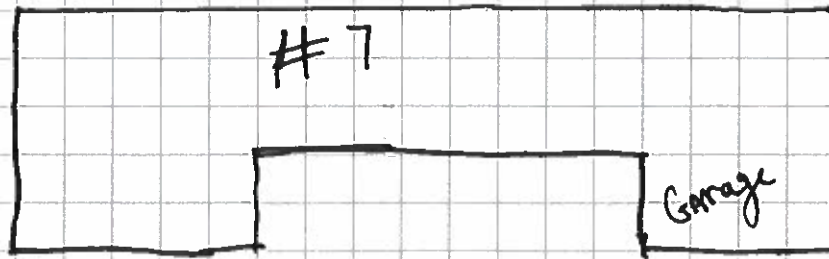
Service was leaking at Corp threads was -  
Direct TAP to AC

3/4"  
McDonald Corp.

6" AC Water Main

Bury Depth  
5'02"

9-3-20  
Installed 3/4" saddle  
new 3/4" corp.
